Important Product Information

PACSystems* RX3i

IC695CPU315-CR

GFK-2586T
April 2016

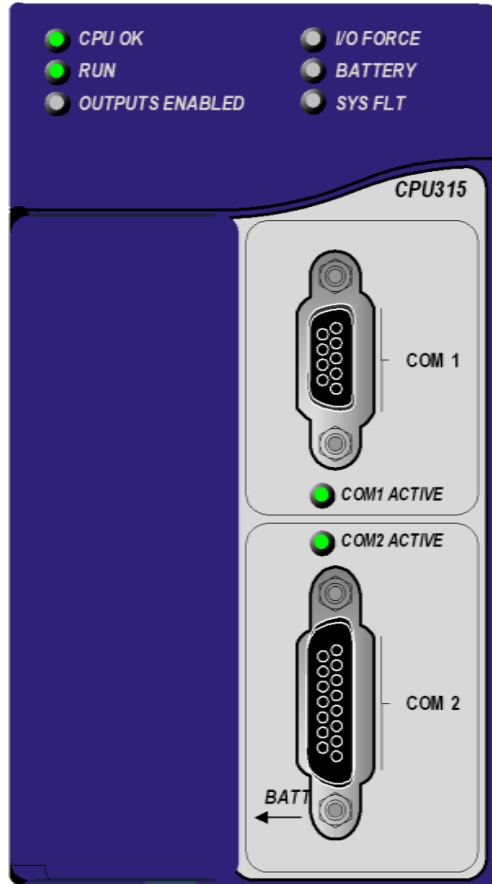
The PACSystems* RX3i CPU can be used to perform real time control of machines, processes, and material handling systems. The CPU communicates with the programmer and HMI devices via a serial port using SNP Slave protocol. It communicates with I/O and smart option modules over a dual backplane bus that provides:
