# PACSystems\* RX3i

## IC695PNC001-AJ

### PROFINET Controller Module

GFK-2573K

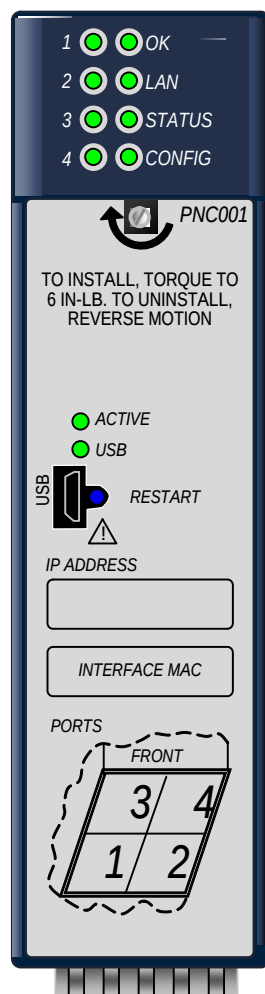
- Four switched Ethernet ports - two 8-conductor RJ-45 shielded twisted pair 10/100/1000 Mbps copper interfaces and two Small Form-factor Pluggable (SFP) cages for user-supplied SFP devices.

- LEDs: OK, LAN, STATUS, CONFIG, ACTIVE, USB, and four Port LEDs.
  - Compliant with EU RoHS Directive using the following exemptions identified in the Annex: 7c-I and 7c-III.
